Carradale North Storm event

North Kilbrannan

Carradale North Storm Event

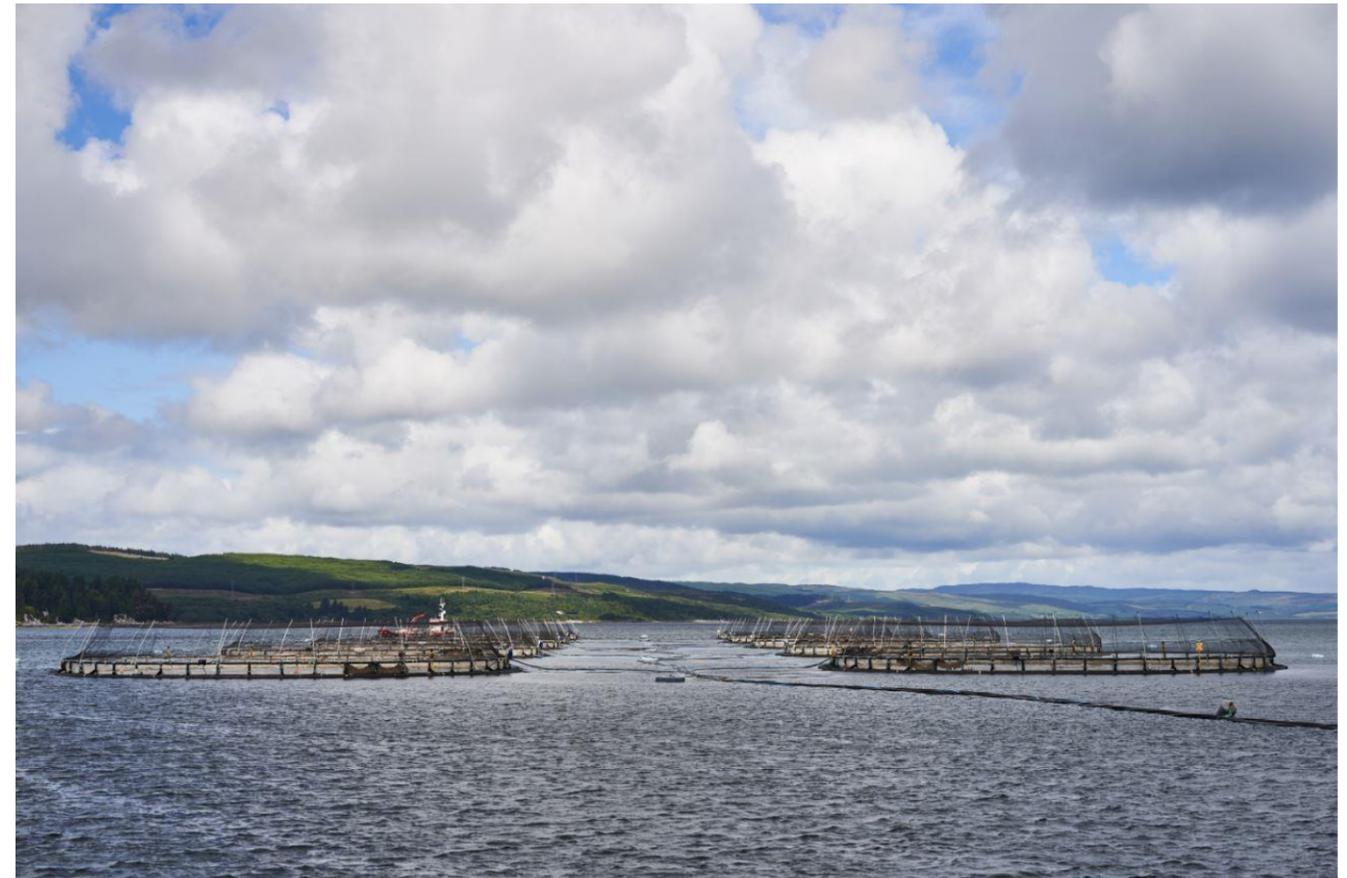
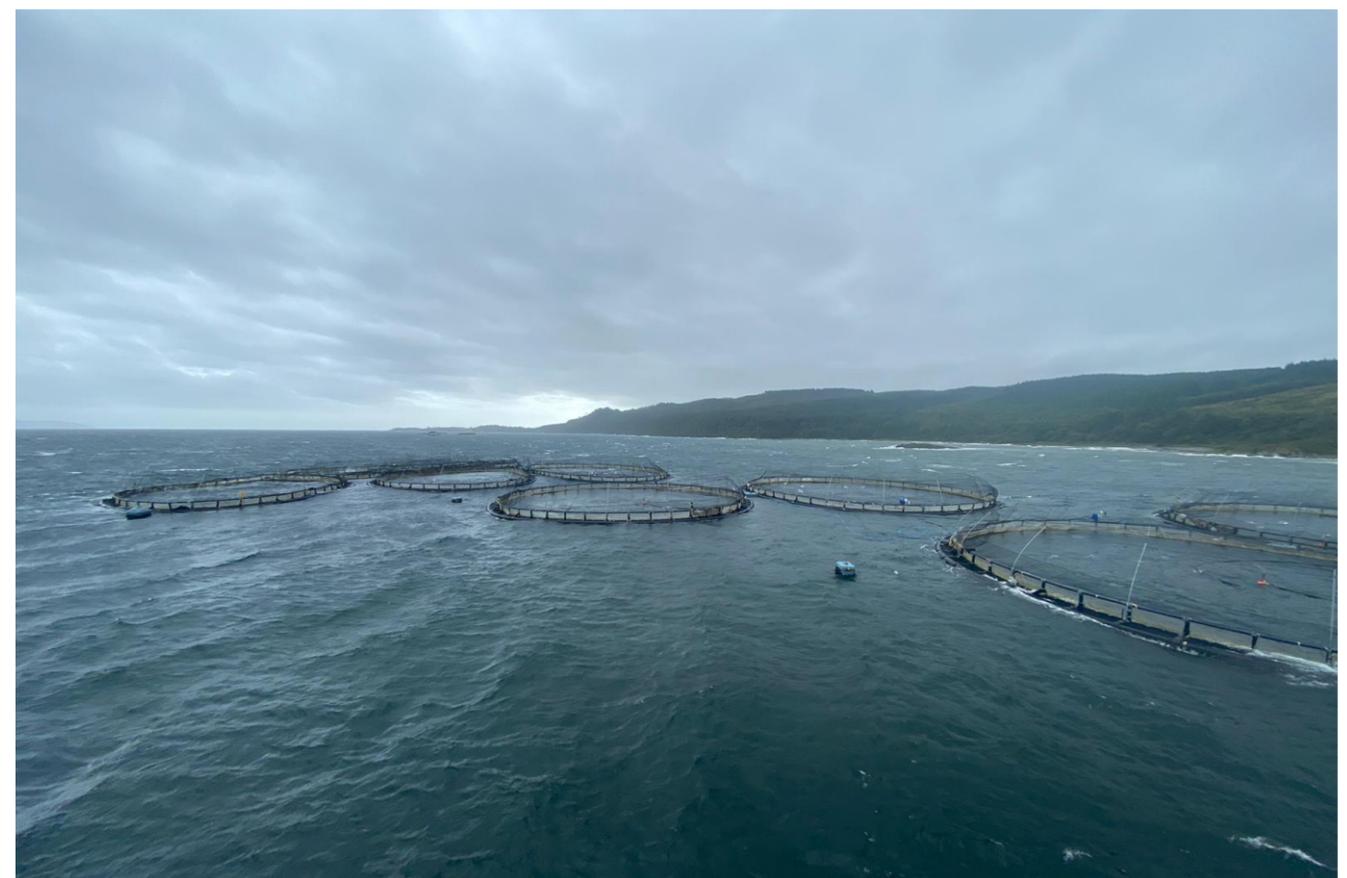
By 25 August 2020, the farm was secured back in its licensed location and all 10 pens were visually inspected for integrity and/or inventoried.

Professional dive teams thoroughly inspected the mooring infrastructure and broken mooring lines were recovered.
